Otter and Water Vole Survey Report 2014

Abergelli Power Project

Otter and Water Vole Survey Report

<b>Client</b>	Stag Energy
<b>Job</b>	Abergelli Power Project
<b>Report title</b>	Otter and Water Vole Survey Report
<b>Draft version/final</b>	FINAL
<b>File reference</b>	7399_R_Otter+water vole_APPR(3)_01102014.docx

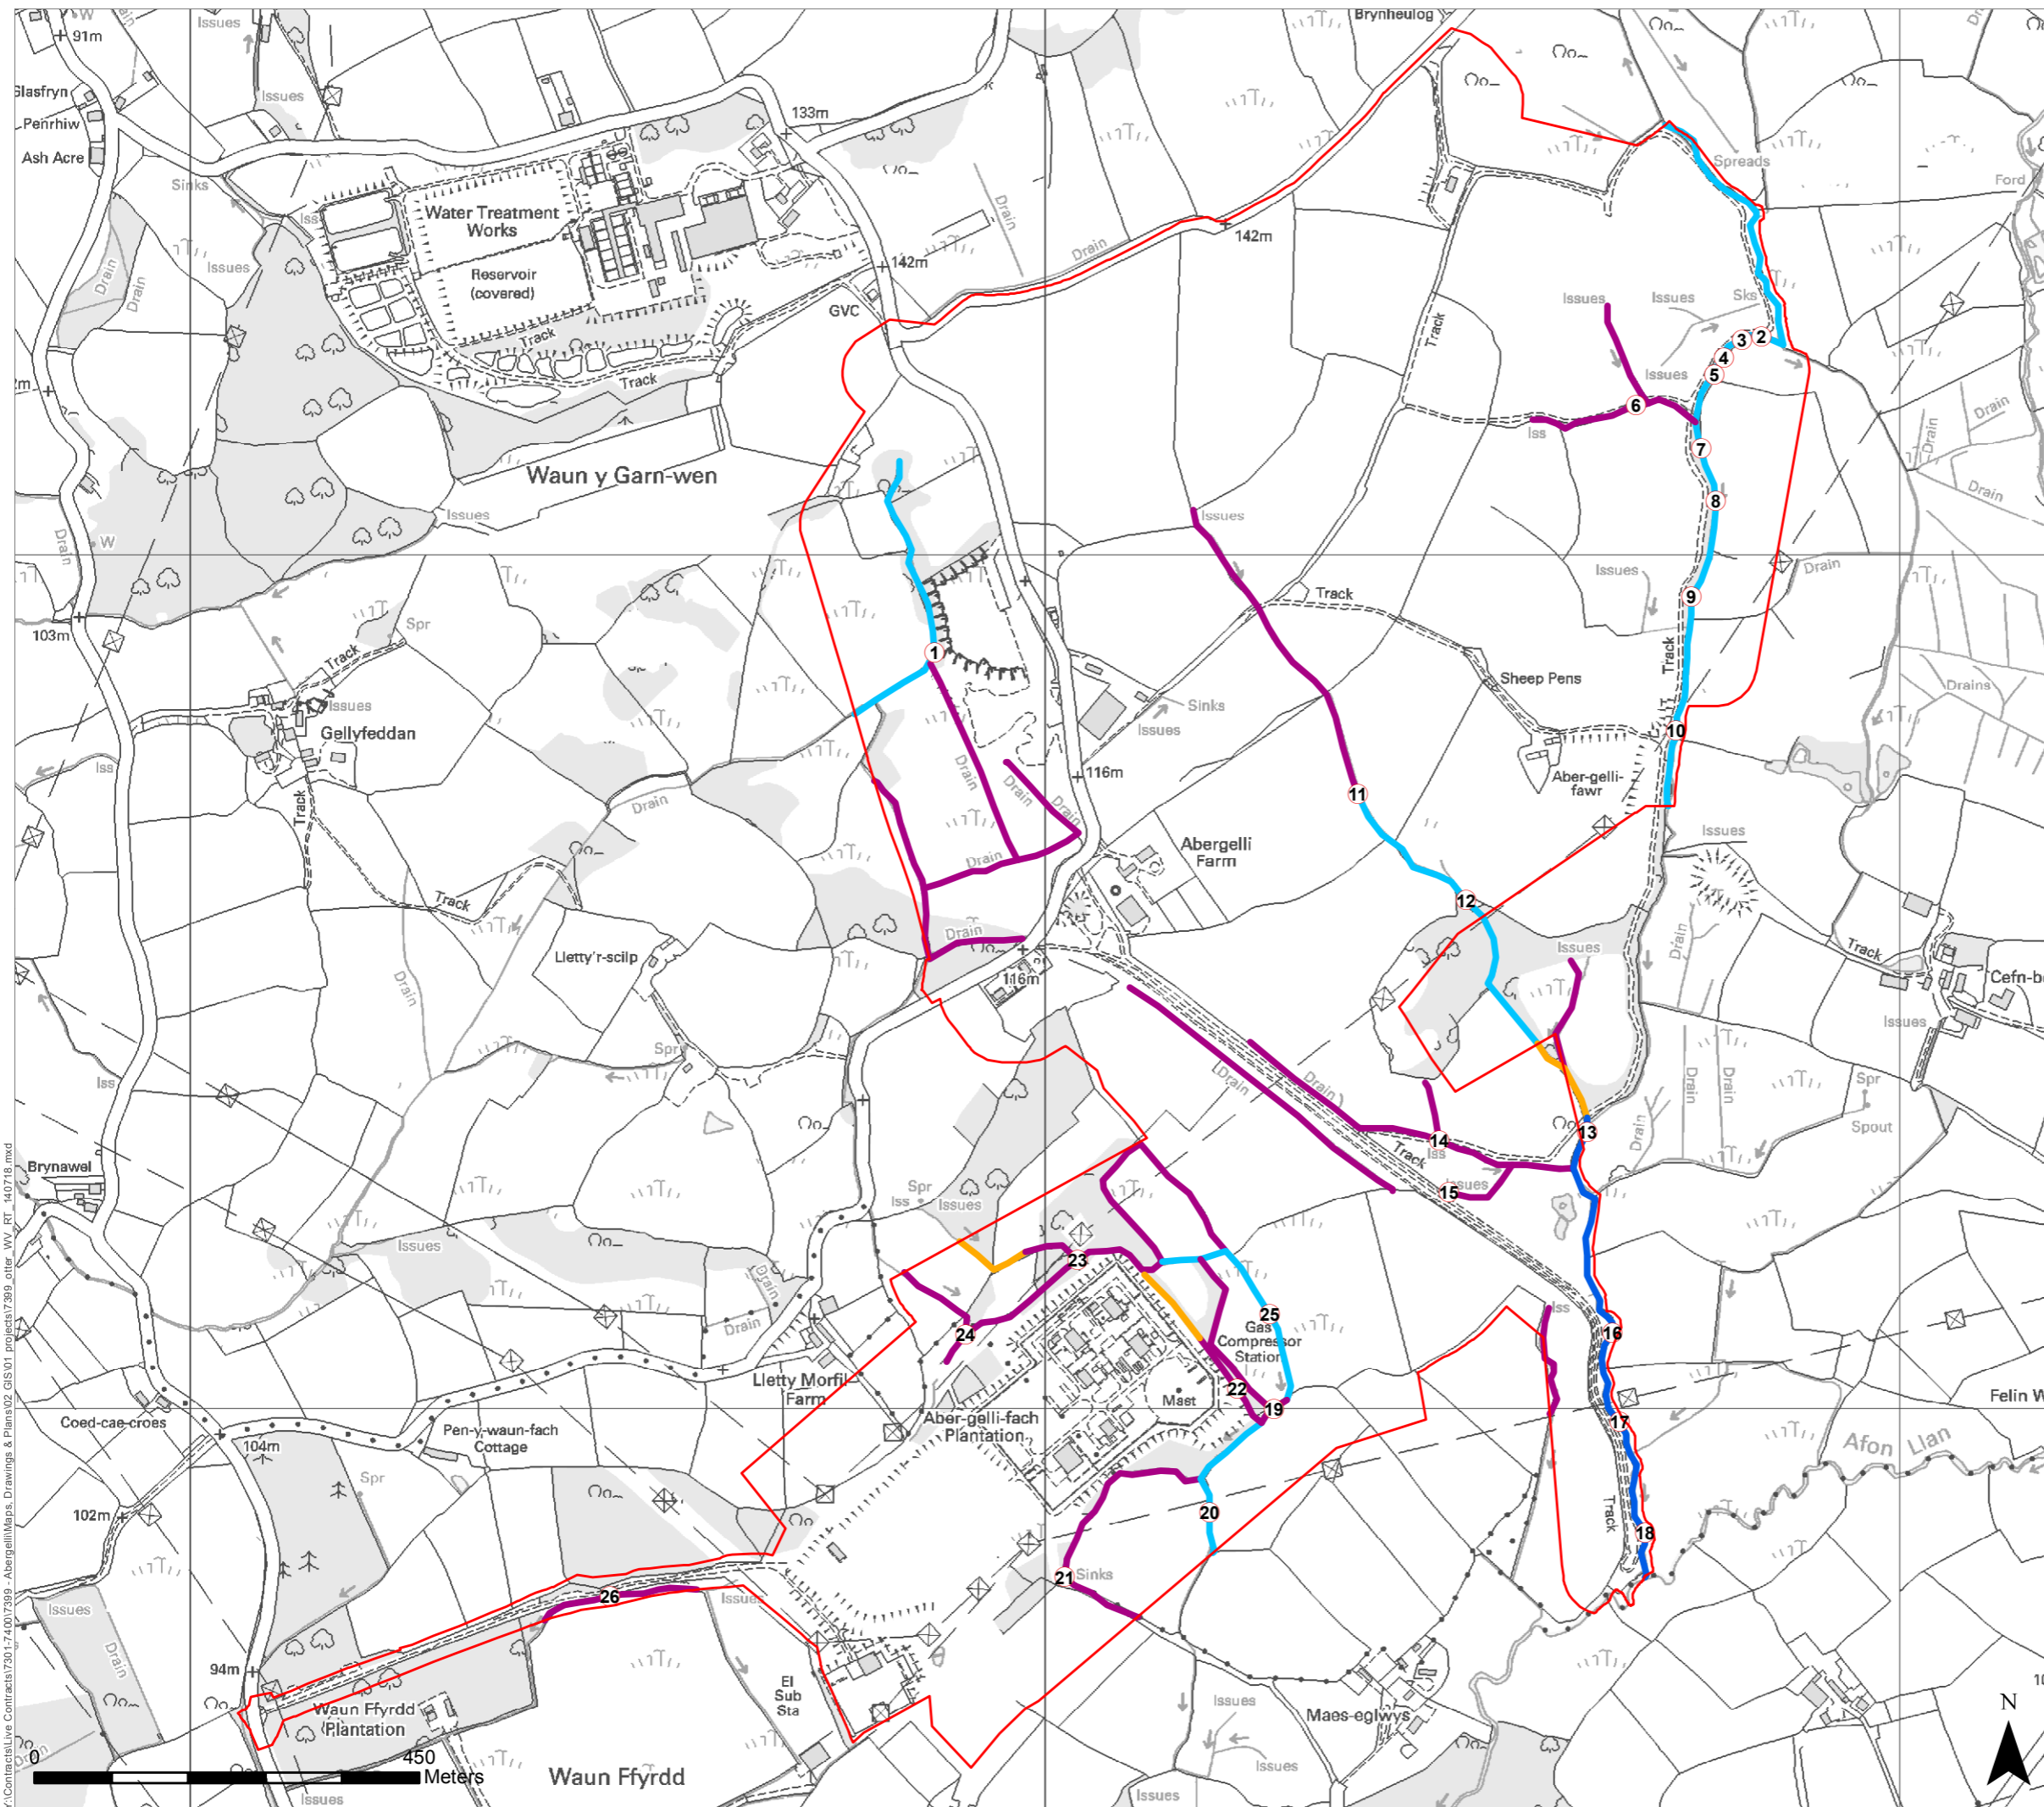
DRAWING TITLE  
**Figure 1 - Otter and Water Vole Survey**

- 4.2 A single fresh otter spraint was found in the stream that runs along the eastern boundary of the Survey Site (see TN3, Figure 1, Appendix 1; and Appendix 2). At this point the stream is approximately 15 cm deep and with a bed of mud, gravel and rocks, the eastern bank is approximately 2 m high and sheer with over hanging trees. The western bank has an approximately 45 degree grass slope and is approximately 1.5 m high.

3. A fresh otter spraint was found on a large, flat stone in the middle of the stream.
4. A pair of holes was found in the east bank approximately 1.5 m from the water line, which had dimensions suitable for use by water vole and/or bank vole/rat. No other field signs were observed.

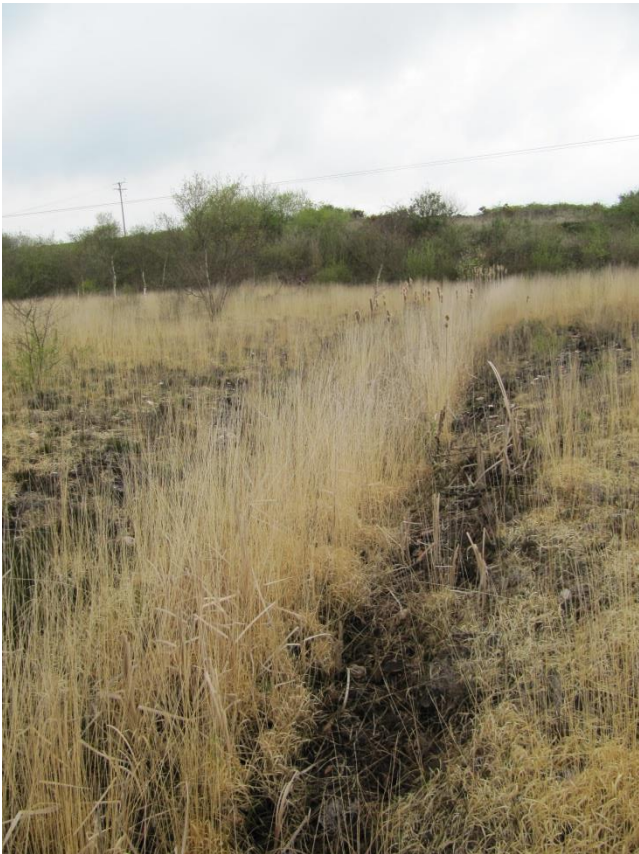
To the south of TN1 is a marshy field with a network of ditches - At the time of survey (May) these ditches were dry or contained very little water and had steep banks with very little or no vegetation.

**Photograph 1** : Damp ditch in field to the south of TN1

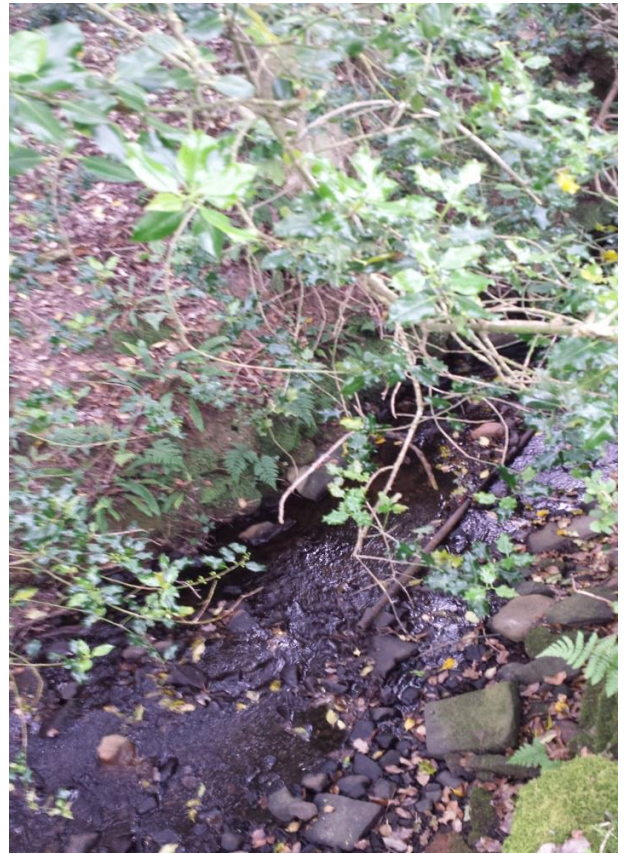
10. The stream becomes very shaded at this point, and the eastern bank is largely undercut providing several potential resting places for otter. No field signs were observed.

**Photo 2**: Stream along eastern boundary (TN10)

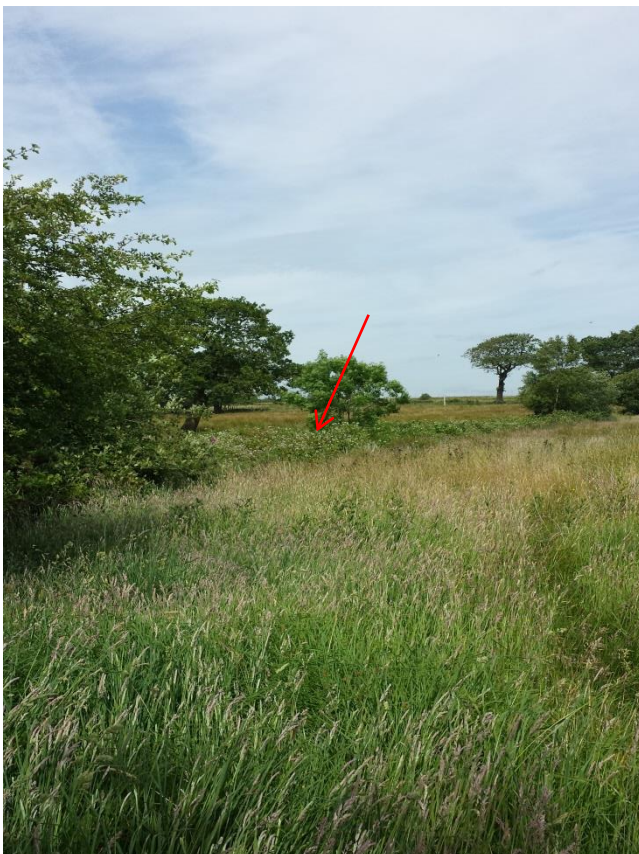
**Damp ditch/brook at TN11 to TN12** – to the north of TN11 this is a dry to damp ditch that has mainly bare banks, with some areas over-grown by bramble. It is open to horses and sheep and the land around the ditch is poached. No signs of otter or water vole were observed and this section is considered unsuitable for use by either species. To the south of TN11 the amount of water in the ditch gradually becomes greater until it forms a narrow brook, approximately 10 cm in depth.

**Photo 3**: Dry/overgrown ditch north of TN11, arrow indicates ditch.

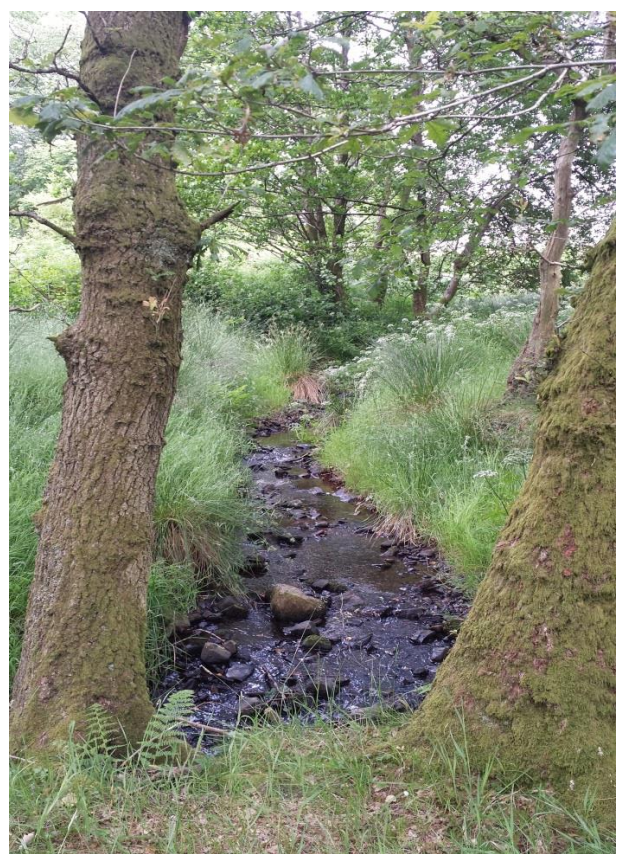
**Photo 4**: Stream south of TN12.

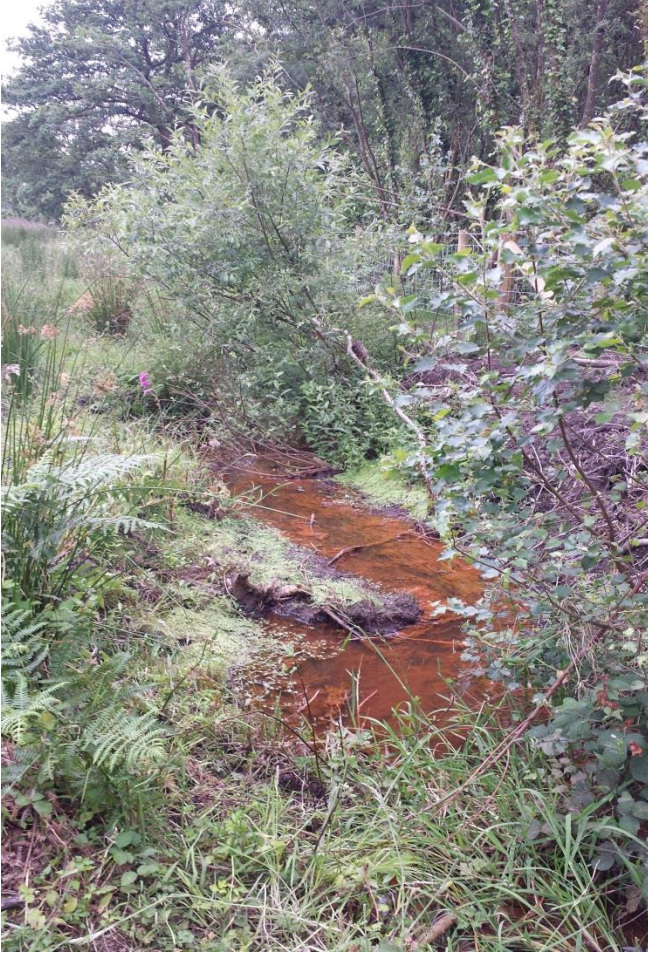
**Photo 5:** Ditch running from a field boundary into the woodland surrounding the Gas Compressor Station.

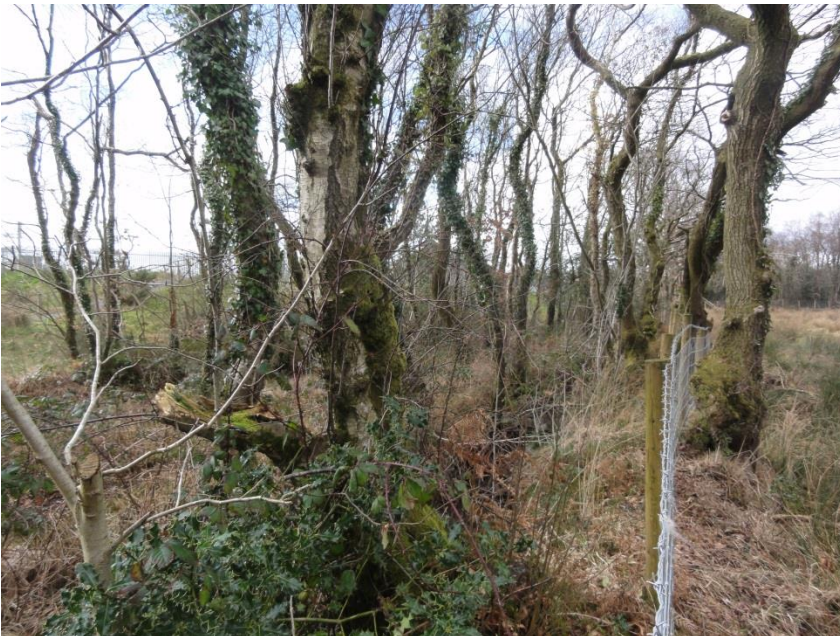
**Photograph 6:** Ditch in woodland north of TN 22 (taken February 2014)
